Vacancy in buildings in growing cities: the case of Dar es Salaam Central Business District, Tanzania

Arnold Mkonyi ^{1*}, Ombeni Swai ^{2*}, Livin Mosha ²

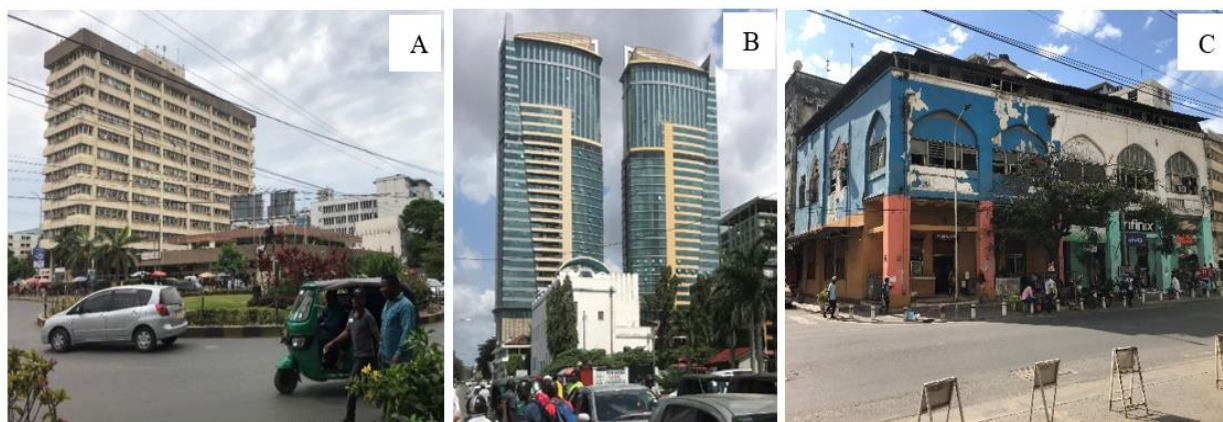
Figure 2. A - The IPS building, B - PSSSF Twin Towers, and C - the HOSCO building (Source: Author, 2021)

Built in the early 1960s, this building is currently jointly owned by NHC and PSSSF under a private company named Housing and Pension Company Limited. The building is located at the epicenter of the CBD, near the Askari Monument (Figure 2 A) and was the tallest and most modern building of its time (Sykes and Waide, 1997). It contains a total of 1015.14 m² of retail rental space on the ground floor level, which is currently priced at 32,600 Tsh/m², and 5093.23 m² of office rental space in the tower (11 stories) structure, priced at 26,048 Tsh/m². The building is currently (as of June 2021) operating at an average 67% occupancy rate: 95% in the ground floor retail space and 54.19% in the office space.

Also known as Gunter House, this building was built before independence in the early 1900s (Edens, 2019). It is located at the corner of Samora Avenue and Mosque Street (Figure 2 C). The building is currently composed of two structures that are connected by a narrow mid-section. One side of the building faces Samora Avenue while the other faces India Street. The two-and-a-half-story structure facing Samora Avenue was built first and meant to be used for both commercial and family residences. After independence, it was privatized by the government. During that time, it housed a government entity called Household Supplies Company (HOSCO) that sold office and household supplies and equipment to government offices. The other part of the building was built at a later stage and used for commercial purposes on the ground floor and offices on the upper floors. However, there was a legal dispute over its ownership between the government and individuals who had bought the company. In 2008, the case was opened and went on until the end of 2014. The government won the case and evicted all the occupants in 2015, only to start reoccupying it at the end of 2019.

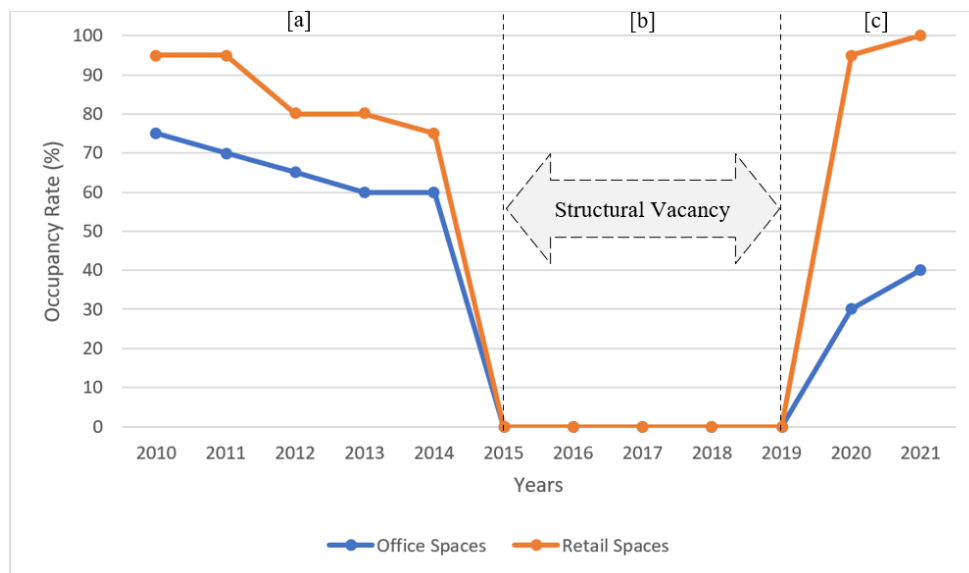
Figure 5. HOSCO building's annual occupancy rates from 2010–2021 (Source: Constructed from Proper Consult annual report records)

Graphically presented in Figure 5, the building gradually lost its occupants during the time of its court case (which took 6 years) and was poorly maintained throughout the time, [part a in Figure 5]. When the case was closed, it was handed over to Tanzania Building Agency (TBA) who evicted all occupants and left it vacant from 2015 to 2019, [part b in Figure 5]. In 2020, the building was officially reopened, and the ground floor was immediately renovated and occupied by a restaurant and shops, [part c in Figure 5].

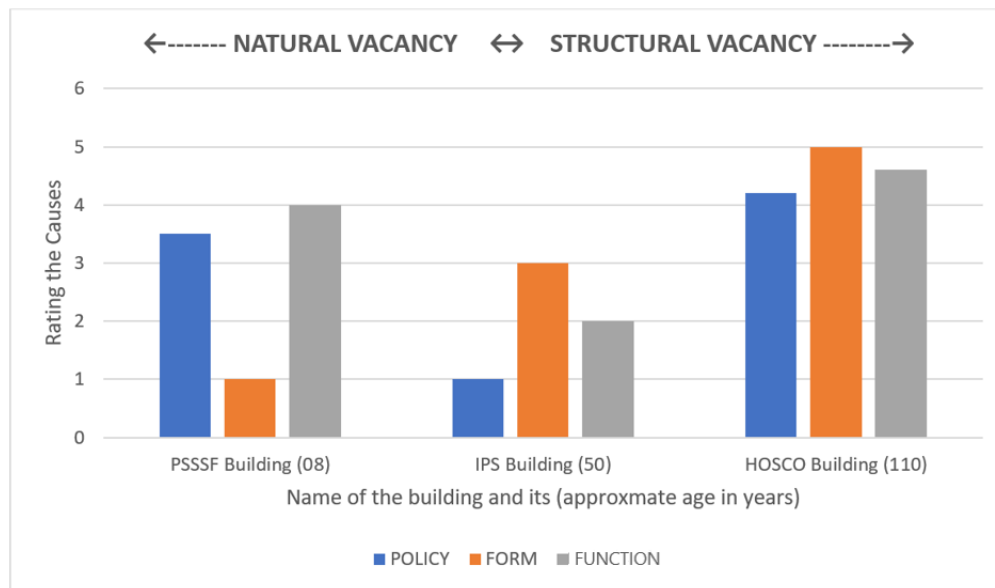
Figure 6. Vacancy due to the building itself (Source: Author, 2021)

The assessment of the causes of vacancy in buildings due to the building itself was conducted through the three main variables, which are the building’s form, its function, and the policies that are related to the owner or its nature of use. Figure 6 graphically illustrates how these variables comparably relate to each other concerning the buildings that were studied by rating them on a scale of 0 to 5, where 0 is non-existent, 1 is the lowest score, and 5 is the highest.

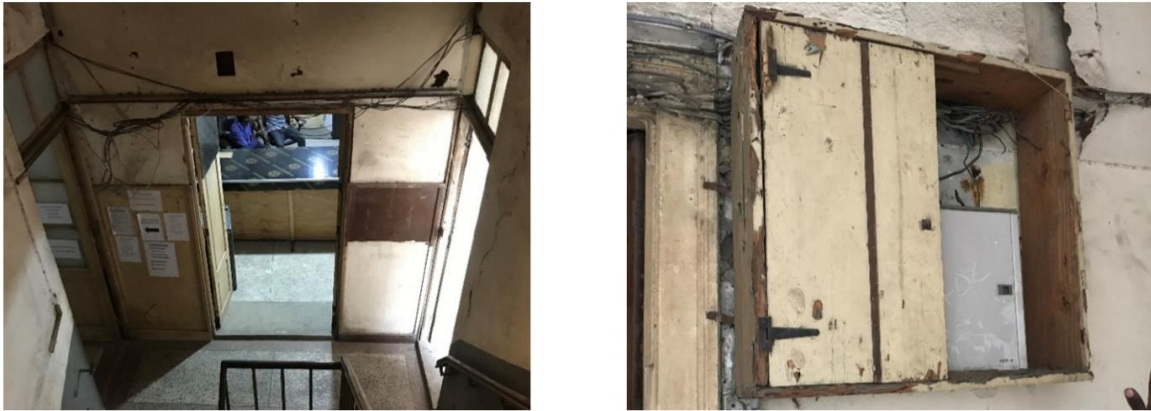
Figure 8. Old and poor electrical service system in the HOSCO building; Left: Exposed, spaghetti electrical wiring systems; Right: Old main switch/control panel (Source: Author, 2021)

With a vacancy in building, building function has been discussed in the aspects of, adaptability to technological advancements and building's functional layout. In line with Baum, (1993) and British Council for offices (2017) migrating office obsolescence, during discussions with property managers and producers such as architects, it was established that older buildings generally tend to fare poorly in this respect when subjected to technological changes. Consequently, older ones such as the HOSCO building were seen to be the most

cumbersome when trying to install new equipment and standards (Figure 8), due to general design considerations that simply never took modern technological means into account.
