Hedera helix L. and damages in Tlos Ancient City

Keywords: *Hedera helix* L., Tlos Ancient City, Plant damage, Turkey

Cite this paper as: Elinç, Z.K., Korkut, T. and Kaya, L.G. (2013), "*Hedera helix* L. and damages in Tlos Ancient City", *International Journal of Development and Sustainability*, Vol. 2 No. 1, pp. 333-346.

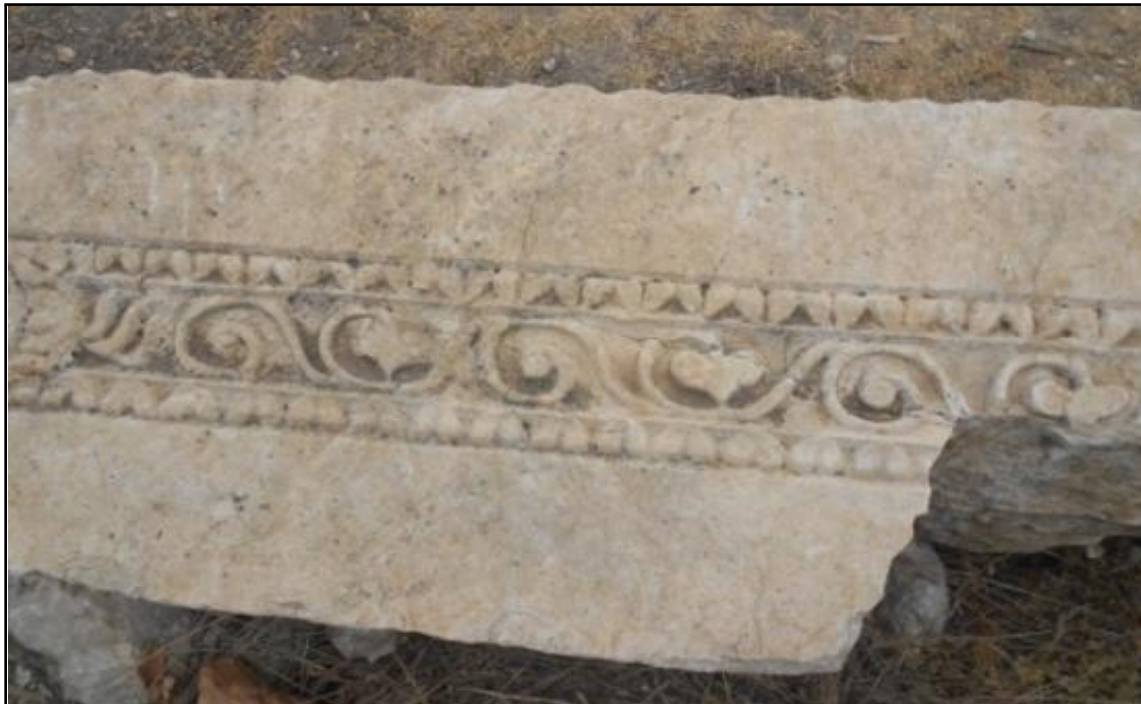
Figure 2. Tlos, Propylon of Large Bath

Plants, which were an indispensable part of the daily life during the ancient times, were also significant symbols of religious beliefs and rituals. For example the ivy (*Hedera helix* L.) is believed to symbolize the Dionysos (Baus, 1940; Blech, 1982). Therefore the sacred places were embellished with special plants symbolizing the related deities during the religious ceremonies or fests organized throughout the ancient times. Also attendants of these ceremonies and fests carried crowns over their heads made of similar plants to honor the deities. Over time, the plan depictions were begun to be used as decorative patterns in architecture. For example, the ivy pattern was used as a curled branch pattern or in a leaf form in friezes, cornices, doorframes and in many other areas. These kinds of findings were discovered during the excavation in Tlos (Fig. 2).

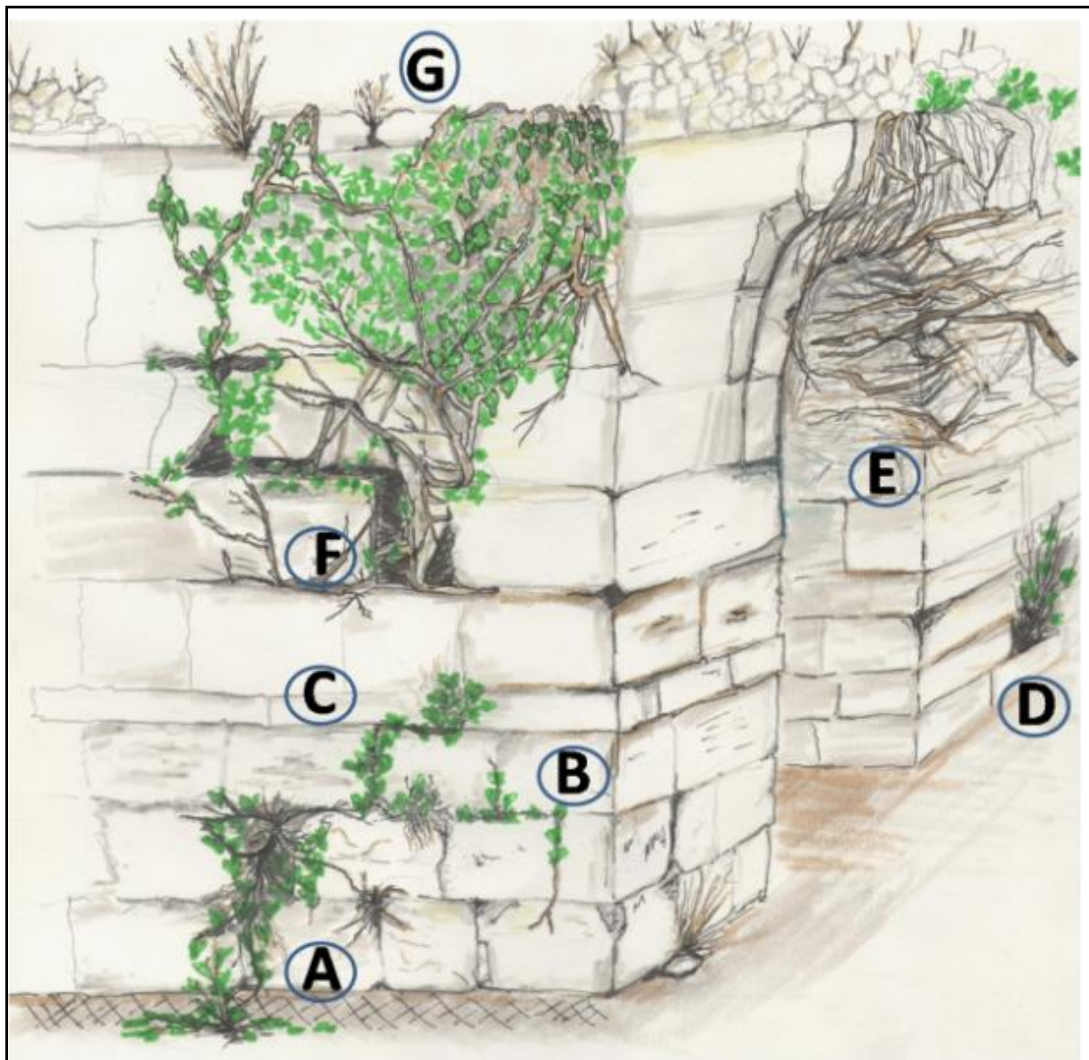
Figure 3. The main microsites for plant growth: A. Climbing from ground;

B. At junction of two same materials; C. At junction of two different materials;

D. Cavities, E. Under arch; F. At junction of vertical and horizontal faces;

G. In horizontal surface (Modified from Lisici and Pacini, redrawn by Sariboyaci for Tlos Project, 2012).

plant situates itself densely on a structure and also a drawing is prepared accordingly (Fig. 3). As one could also see from the figure, the plant started spreading right from the ground next to the structure, and climbed up the structure (Fig 3.A). This climbing plant spreads in the connections of same or different materials (Fig 3.B and 3.C). Additionally the plant locates itself mainly in the empty spaces (Fig. 3.D) of the structure. On the upper parts of the structure, the plant spreads horizontally (Fig. 3.G). It was observed that, the plant spreads mainly right under the arch (Fig. 3.E, Fig. 4). The plant may totally catch the dislocation of the horizontal and vertical meeting points on the structure (Fig. 3.F).

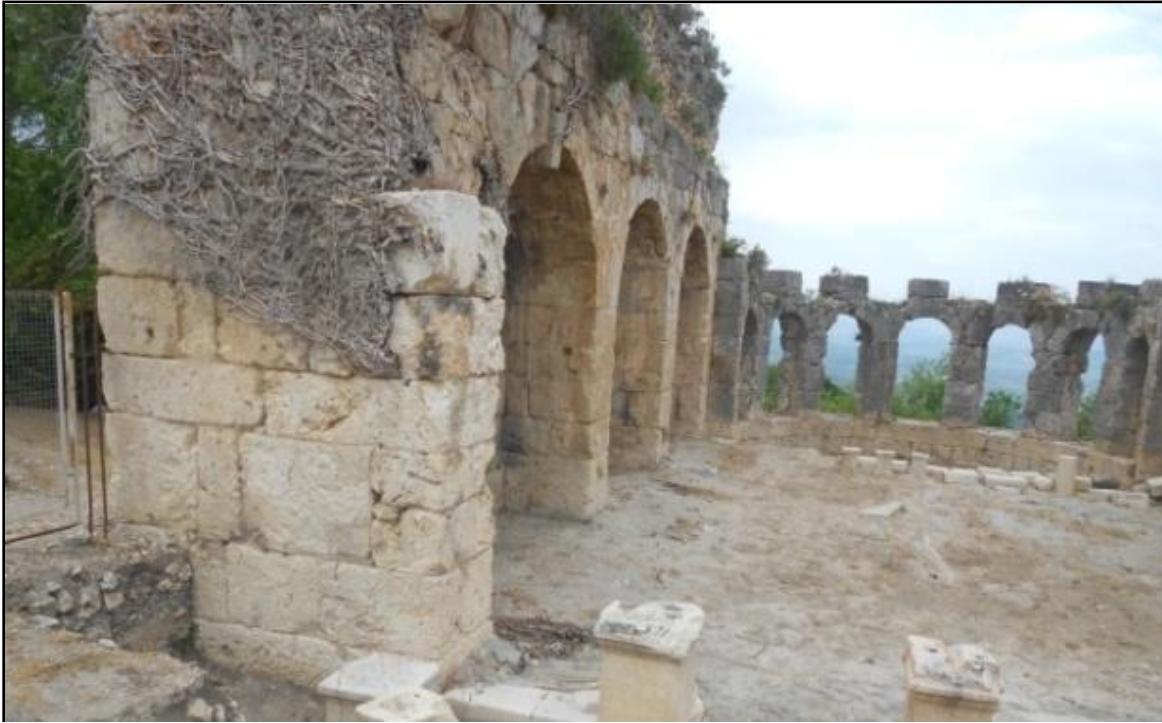
Figure 5. Large Bath in Tlos

It was impossible to remove the plants by hand lifting or by using different instruments as they were holding tightly to the ancients, due to their catching air roots. Therefore, the plants were cut from their pieces close to the soil by pruning or secateurs. The roots of the cut plants are then unearthed (Fig. 5). After this procedure, it was observed that even though the plants dry out in 2 to 3 months, one had to wait 1 to 3 weeks in order to take out the catching roots and hard trunk as they hold really tightly to the ancient structures. It was also observed that, if the roots and trunks were not taken out by human force, they would not pull away the ancient structures.

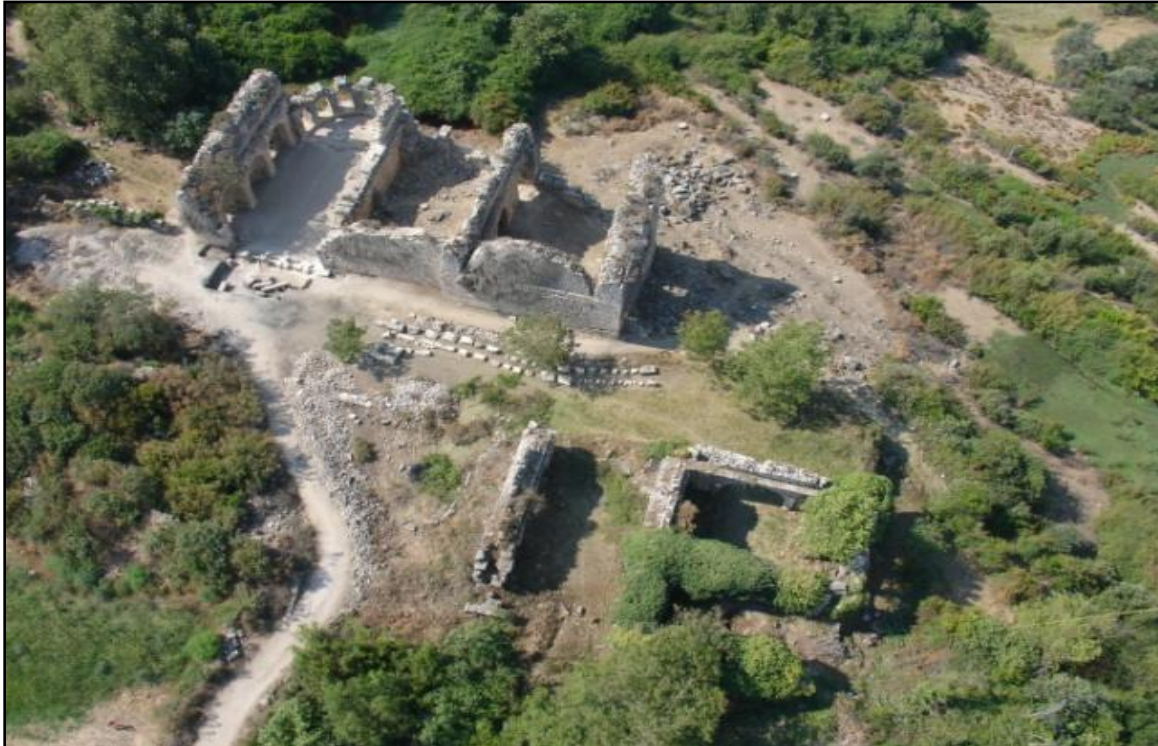
Figure 6. Tlos Ancient City from the air

The above mentioned ways of fighting against *Hedera helix* L. remained unsuccessful. In 2007, the ancient city was photographed from the air, in an air balloon (Fig. 6) and it was observed that the ancient city is covered by plants, especially by *Hedera helix* L. The reason for this is that the natural structure of the city is very favorable for the growth of plants and those plants could spread easily. Finally in 2010, the excavation team needed an effective solution for *Hedera helix* L. fighting and they arranged meetings with real professionals. After strict investigations, it could finally be concluded that the water channels running from the city center were the one of the reason for the rapid growth of this plant and also damage for ancient structures.

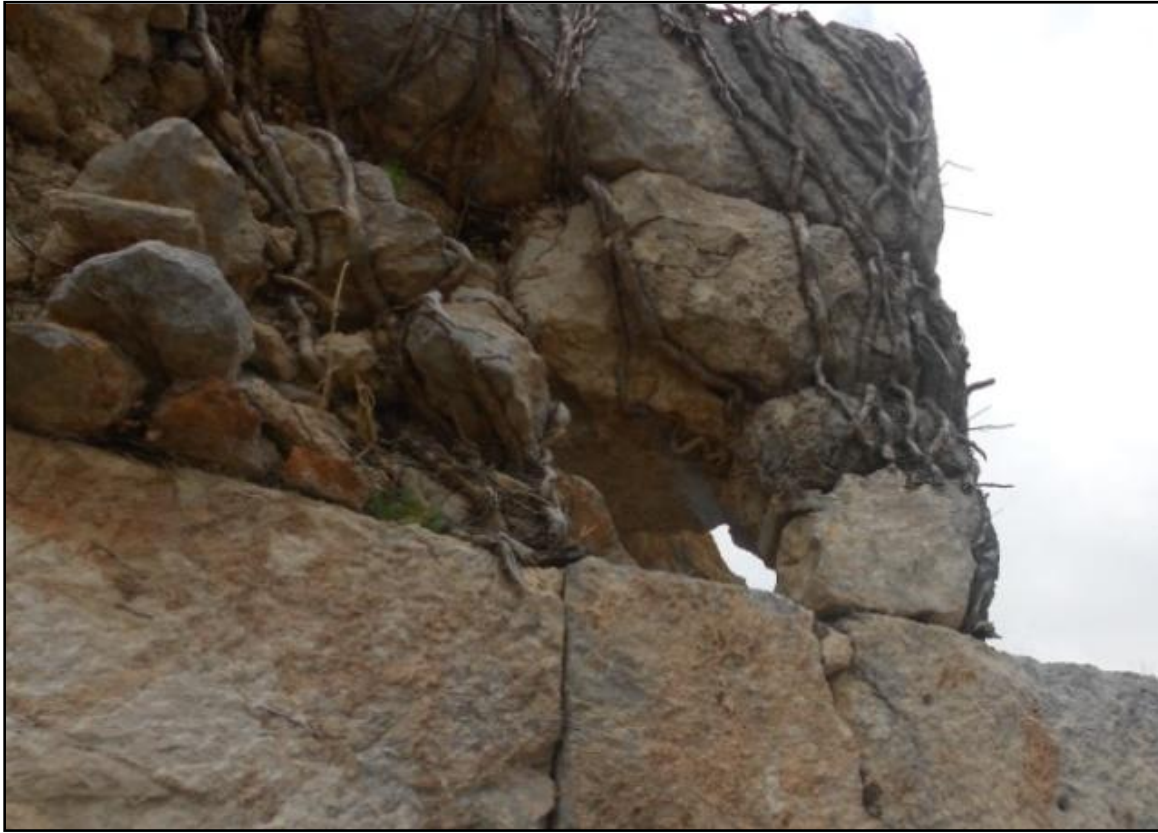
Figure 7. Small Bath in Tlos

Additionally, removing the plant totally from the structure may cause serious damages, because as the time passes, the plant sticks itself on the plant, with a catching role (Fig. 7).

Such places should be determined beforehand and the cleaning personnel should be informed about it. Otherwise structures may be destroyed during cleaning up. It was also observed that during the study, the spreading of the plant does not show any difference according to the direction, age and structure material at all. One could see that the plant started spreading right from the ground next to the structure, and climbed up the structure. The plant situated itself also on empty places on the structure. It was also seen in the work field that, the plant could reach up to the upper parts of the structures and from there they cover the lower sections of the coves totally. Finally, they locate themselves between the materials of the structure and ruin the mortar. This plant, which was embossed on the stones during the Ancient History as a symbol of Dionysus, became a nightmare of the ancient structures, which managed to survive until today.
