Comparative analysis of lining materials for reduction of seepage in water harvesting structures, Adet, Ethiopia

Menelik Getaneh ^{1*}, Amare Tsigae ²

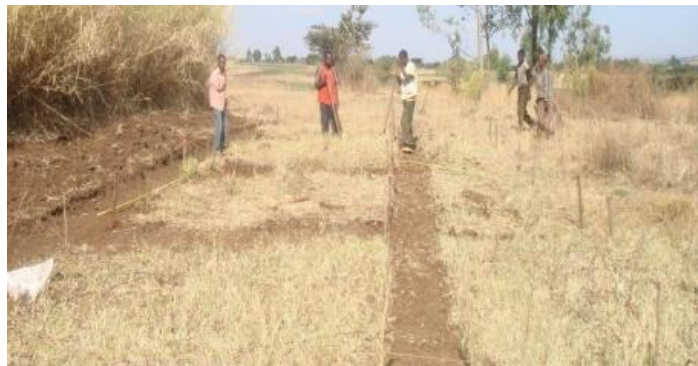
Before starting the actual excavation work, the lay out work was done first. Square plots of area 3m x 3m were marked on the ground using pegs (Figure 1).

Figure 1. Land lay out work

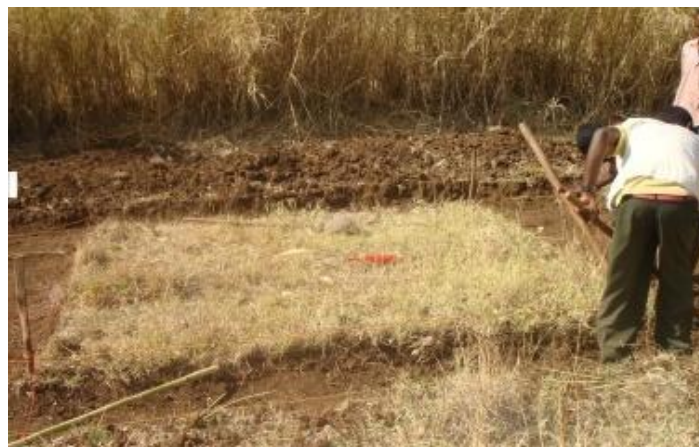
Figure 2. Land leveling work

From the edge of these squares 0.5m area is marked around each square and leveling work is done only on this part rather than leveling the whole plot area (Figure 2). This area later served as the edge of the pond and as a zero level for the pond (Figure 3). Pond excavation work was then started step by step and layer by layer down to one meter depth. To attain the actual pond side slope of 1:1 (H: V) we followed two types of excavation procedures, refill and cut type (Figure 4).

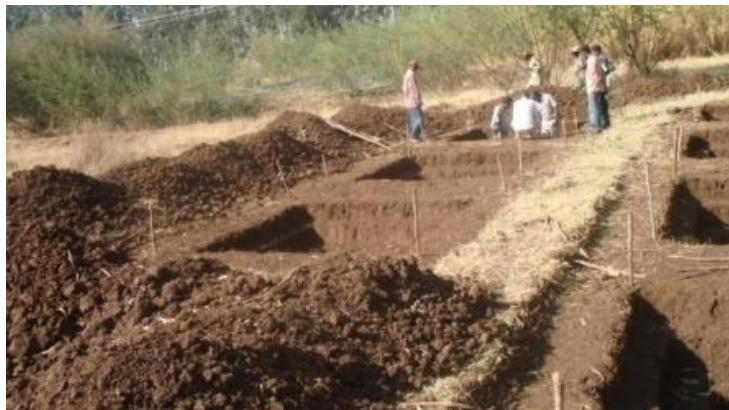
Figure 3. Edge of the pond

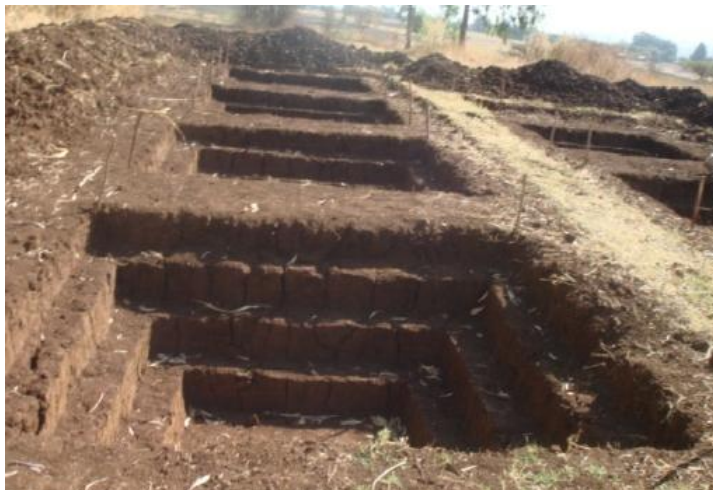
For the cut type procedure 25cm was measured inside the 3m X 3m square area from the edges and marked by pegs at the four corners. The area was enclosed with Nylon rope and the remaining 2.5mx2.5m square area was excavated to a depth of 25cm. Again after maintaining 2.5mx2.5m square and level area,

another 25cm is measured inside this square from each edge and 2mx2m square area is delineated. This square plot is again excavated to a depth of 25cm. This procedure is repeated up until a total of 1m depth and 1m X 1m square bottom area is obtained (Figure 5).

Figure 5. Step by step digging procedure followed during pond construction at Adet

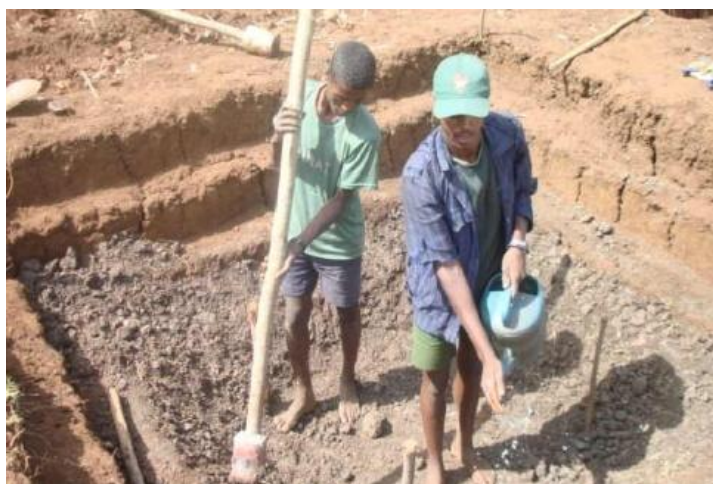
Figure 6. Clay re-filling technique used at Adet

For the clay fill pond, clay material (Vertisol) was transported to the area and step by step filling was done starting from the base by compaction (Figure 6). Small amount of water was applied during compaction to moisten and facilitate binding of the soil material. Then the set of stairways were re-filled carefully up until the desired side slope (1:1) and smooth surface was finally maintained (Figure 7).

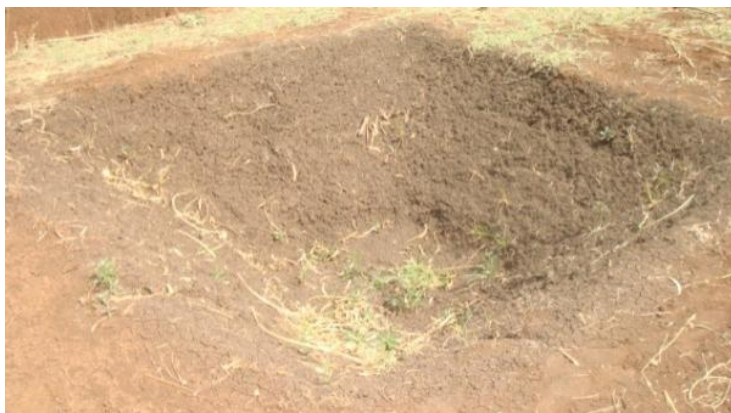
Figure 7. Actual shape of clay lined pond

Significant Variation in storage efficiency was seen only in Luvisols as compared to the Vertisols. Clay filled ponds were seen to be less effective. This may be due to existence of internal crack in the structure and presence of loose interface between the two clay layers. On the contrary, application of Sodium Chloride

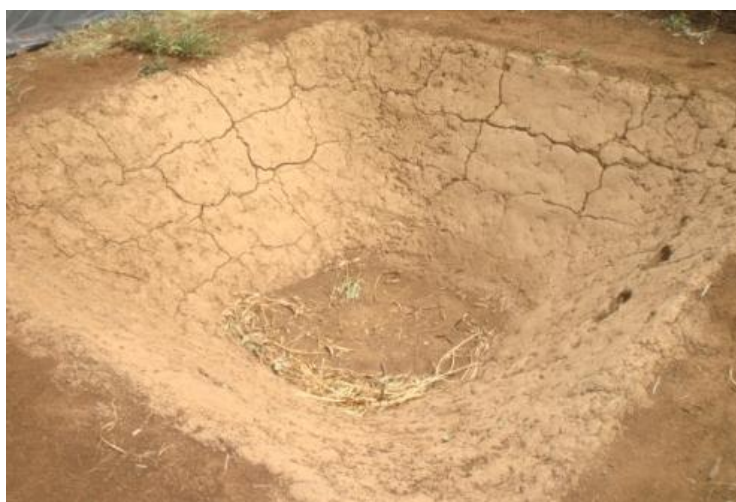
Figure 8. Actual shape of cement + soil lined pond

For cement +soil filled pond, cement and excavated soil material were mixed in 1:5 ratio. The bottom area of the pond excavated to 15cm depth and re-filling of the subsequent stairs started from the base of the pond (Figure 8).

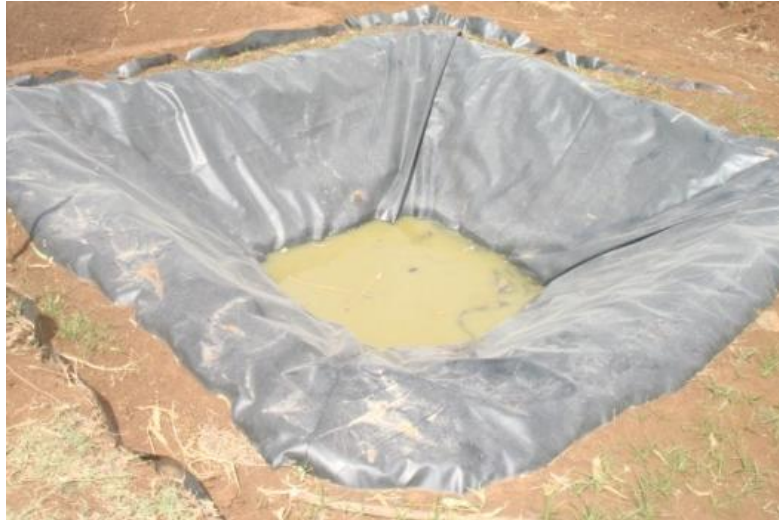
For the remaining ponds (i.e. Geo-membrane lined pond, Table salt treated pond and Control), side slope was maintained by carefully re-shaping the subsequent stairs step by step. In the geo-membrane lined pond, the pond surface was covered with plastic sheet after smooth 1:1 (H: V) side wall was maintained. The edges of the plastic sheet were buried under soil by digging ditch around the edge of the pond (Figure 9).

Figure 9. Geo-membrane lined pond

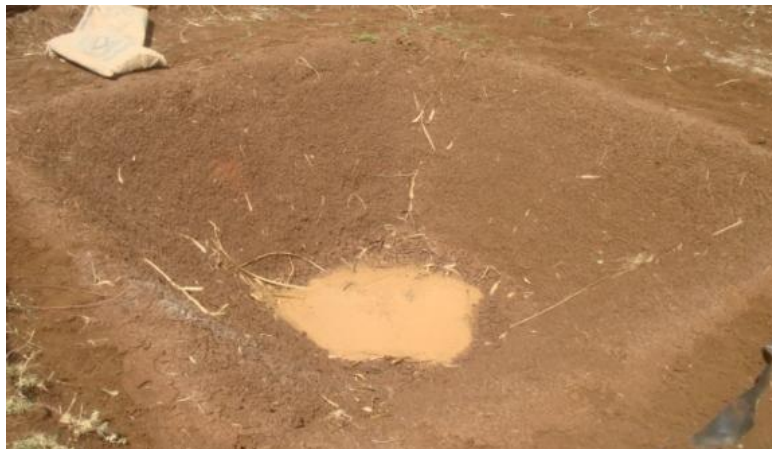
Figure 10. Table salt treated pond

For the table salt treated pond, around 11.5kg of table salt was dissolved in water and applied on the pond surface at a rate of 2kg/m² during the first application. Again after a week the remaining 11.5 kg was applied (Figure 10). The control pond is also excavated in the similar fashion by reshaping the subsequent stairs and was left untreated (Figure 11).

Salt treated pond showed better storage efficiency next to the geo-membrane lined pond. In this experiment table salt was applied in the soil to create sodium-induced clay dispersion on the soil. The principle works in such a way that dispersed clay particles within the soil solution can clog soil pores when the particles settle out of solution. Additionally, when dispersed particles settle, they form a nearly structure-less cement-like soil depending on the sodium concentration and clay type. This pore plugging and cement-like structure in-turn impedes water flow and water infiltration into the soil (Silva and Uchida, 2000).

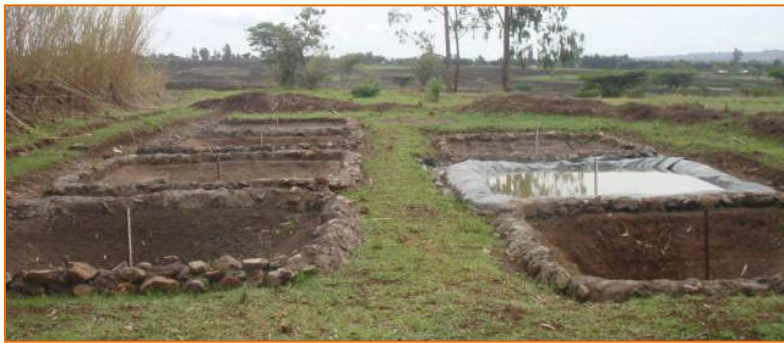
Finally, the edges of all ponds were constructed with stone masonry so as to avoid uncontrolled entry of external runoff into the pond (Figure 12). To monitor the daily water level (depth) in the pond, stationary graduated measuring bar was prepared from iron bar by painting, leveling and with concrete footing. Totally, five ponds on Luvisols and three ponds on vertisols were constructed and filled with water and the respective data collection process continued accordingly. Finally, daily storage efficiency and Present Effective cost per unit volume, labour and material requirement were calculated for each pond.

Figure 12. Final Experimental Setup

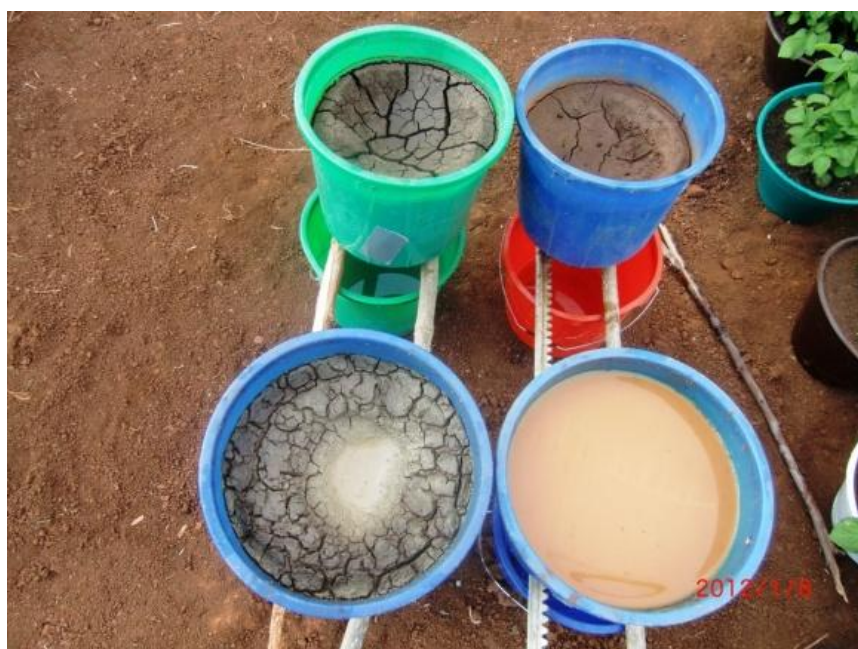
Equal volumes of disturbed soil samples (Figure 13) were taken in four buckets from both soil types (Luvisols and Vertisols) and treated with table salt at a rate of 2 kg/m² under controlled / laboratory condition.

**Figure 13.** Storage characteristics of table salt treated and un-treated soils compared at Adet during 2009/10 to 2010/11

Laboratory assessment also vividly proved dramatic improvement of storage with salt application. Moreover, analysis result of the stored water after treatment showed low to medium salinity, implying the stored water can safely be used for irrigation. But its impact on crop should be assessed further in future research. Impact of salt on soils other than Luvisols and Vertisols should be seen further. The amount of salt to be applied and the effective duration/life span of the applied salt also needs further research. Moreover, the result should be seen at large scale by increasing the size and volume of pond and with introduction of different test crop having varied salt tolerances.
